A Concrete House With Untreated Surface

RESIDENCE OF MRS. GASTON DAUS, OCEAN CITY, N. J. BUILT OF "GIANT" PORTLAND CEMENT.

[From CEMENT AGE, Feb. 1910]

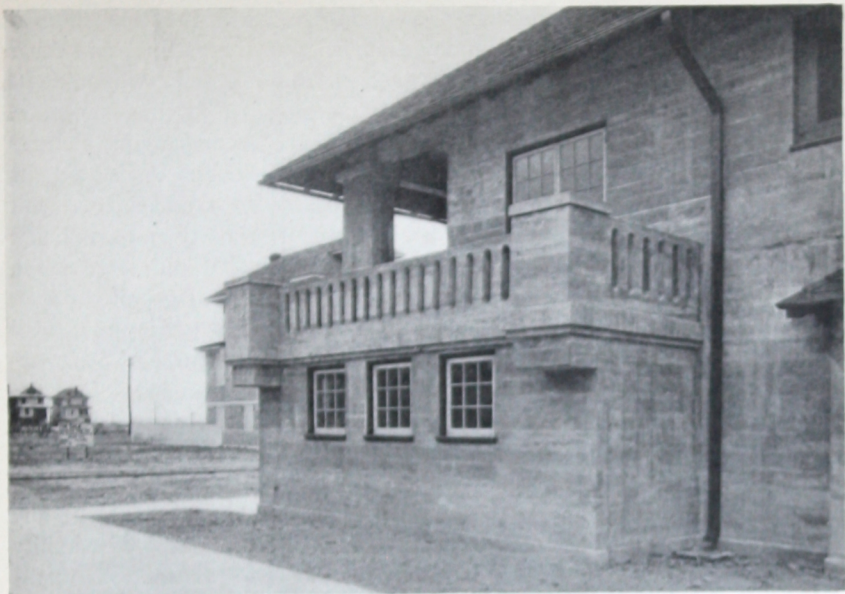
FIG. I.—DETAIL VIEW SHOWING TEXTURE OF WALLS AND SUBSTANTIAL CONCRETE POSTS AND BALUSTRADE OF PORCH.

The large square posts are hollow, with drainage at the bottom, and will be utilized for plants.

The party wall is entirely concrete from the ground to the roof. The entrance porch is solid concrete, including the floor, steps and balustrade. It is 9 feet wide, and 8 feet 6 inches above the sidewalk level, having a return at one side as shown in the picture. A decorative design in Moravian tiles in high relief will be set in the panel shown in the front. Similar decorations will be placed in the panels at the side of the house. The porch is an integral part of the house and built at the same time. The front wall, in a sense, starts at the porch level, being carried on a reinforced concrete beam.

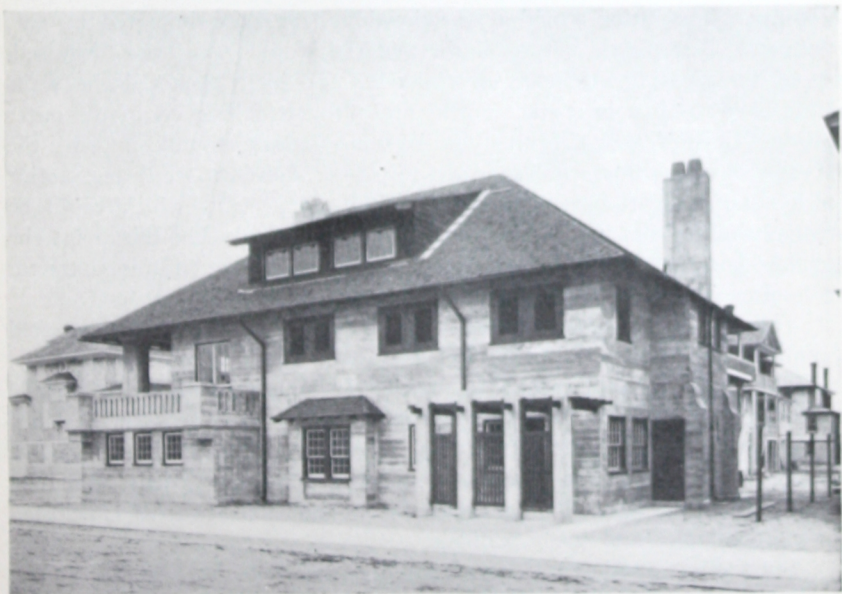
FIG. II.—SIDE AND REAR VIEW SHOWING MASSIVE CHIMNEY CONSTRUCTION AND INTERESTING TREATMENT OF CONCRETE COLUMNS AND GRILL AND REAR ENTRANCE.

The massive concrete chimneys, a feature which may make or mar a dwelling, were cast with the house, and, like the porch, are an integral part of the house. Flue lining was placed upon the inside and the chimneys capped in red terra cotta. The living room fireplace is shown in an accompanying picture. The surface was left as it appeared when the forms were removed.
